Manhole Inspection Summary

Manhole # S29KK_027MH

Location Address: **702 LENNOX ST**

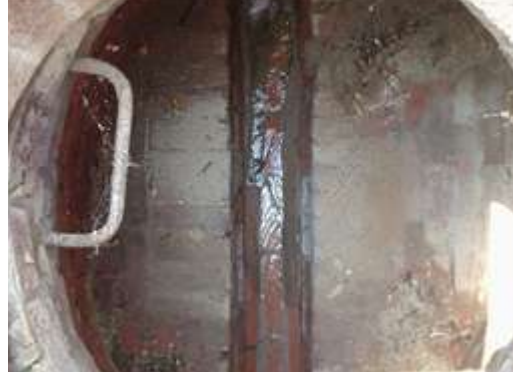
Top View

Bench debris.

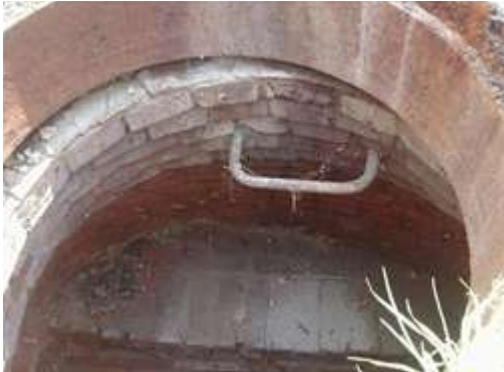
Defect

Frame leaks. Corbel deterioration and infiltration. Barrel infiltration - other side.

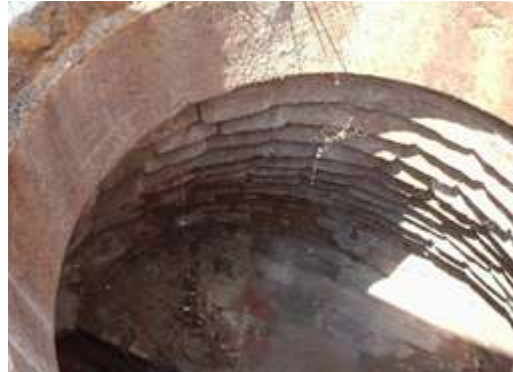
Defect

Frame leaks. Corbel deterioration and infiltration. Barrel infiltration.

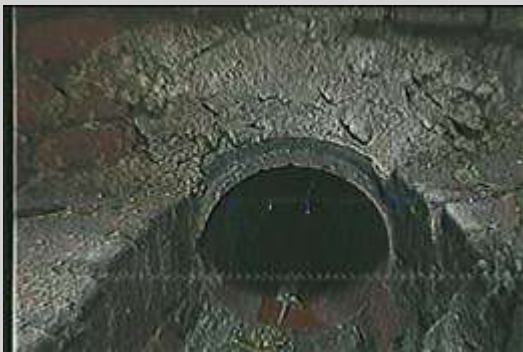
8 in. Circular Gravity Sewer Pipe Out @ 12 O'Clock

Infiltration: **None** Pipe Seal Cond: **Unknown**

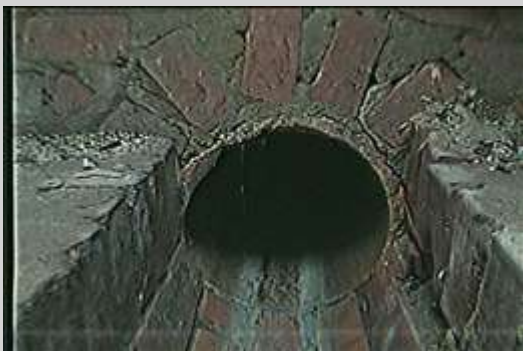
8 in. Circular Gravity Sewer Pipe In @ 6 O'Clock

Bench and Channel deterioration.

Infiltration: **Evidence** Pipe Seal Cond: **Cracked**
